ICE BREAKING

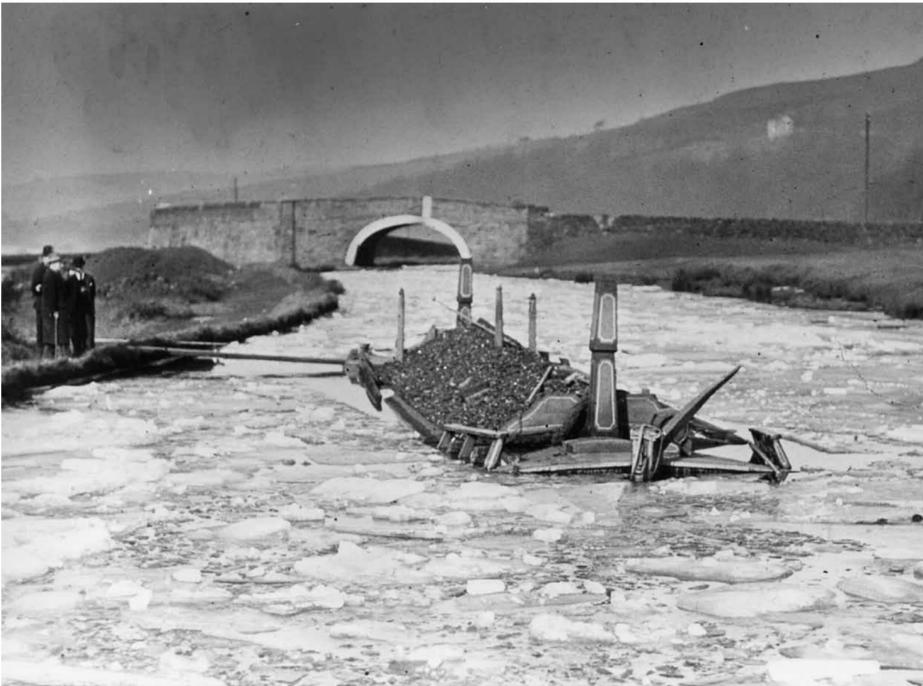
Ice could easily make a hole in a boat, which is why wooden boats had steel sheet ice plating to protect their bows from damage. Here a coal boat has been sunk by ice near Skipton, whilst they were trying to get coal to Skipton gas works during a long cold spell.

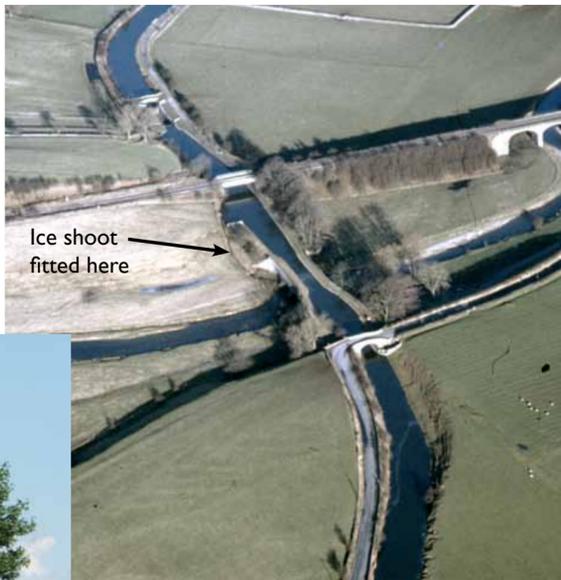
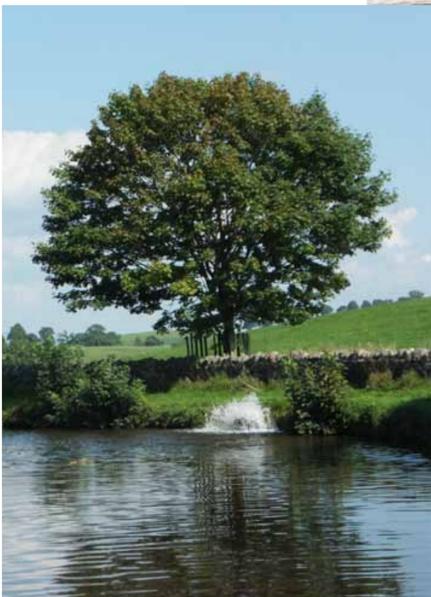
Before winter set in, the carpenters at Bank Newton would install several 'ice shoots', used for clearing broken ice from the canal. Not only could ice damage boats, but it also made working through locks difficult. The ice was floated down the canal to a shoot, where it was raked out and then slide down into a stream or river, such as here at Priestholme aqueduct over the River Aire.

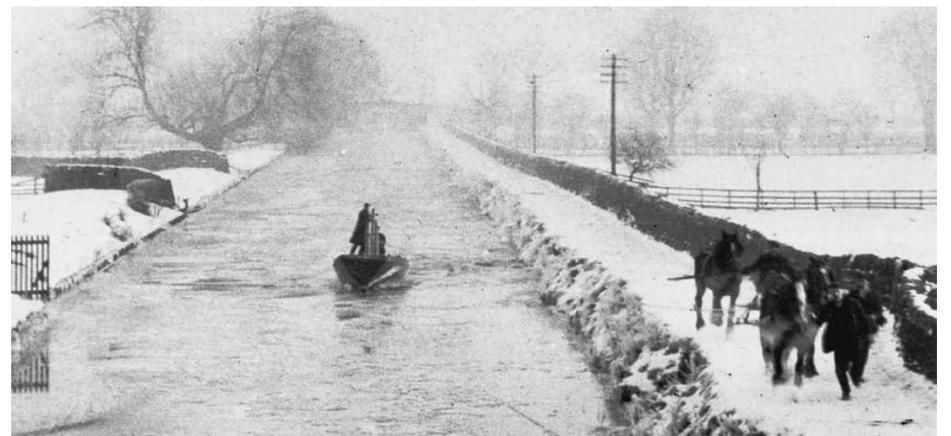
Ice breaking with horses was hard work, and several were needed, even for fairly thin ice. Here three horses are towing the ice breaker at Gargrave. There are only a couple of men on the boat, so the ice was probably not very thick. The ice breaker would rise up onto the ice, which was then broken by the men rocking the boat from side to side. The thicker the ice, the more men were needed. Occasionally, the boat would be pulled out onto the ice and the horses could then fall over, such was the force needed. This may have happened below.

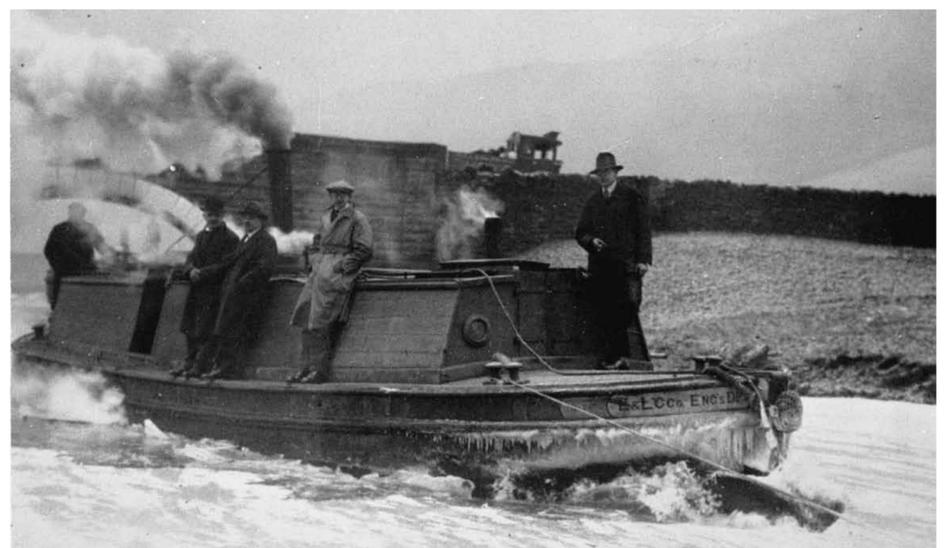
Several steam tugs were equipped for ice breaking. Here, the Skipton tug, **No. 57**, has had its iron ice-breaking frame fitted to its bow. This started the ice breaking and reduced the possibility of damage to the tug's wooden hull, even though it was fully protected with steel sheet ice plating. Several of the office staff have obviously come along to check on conditions.
